**SOUTH SHROPSHIRE CLIMATE ACTION
BUILDINGS RETROFIT CASE STUDY
*THE TAN HOUSE, LITTLE STRETTON***

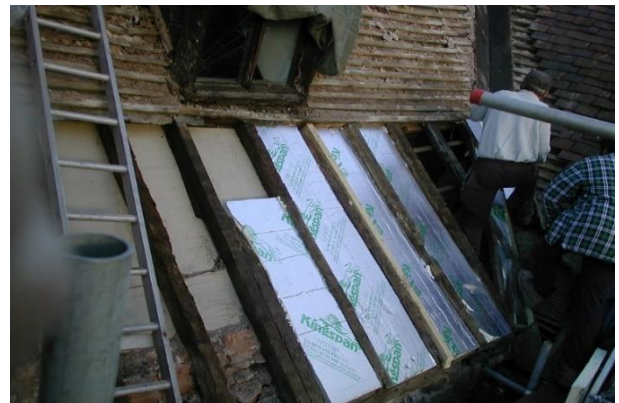
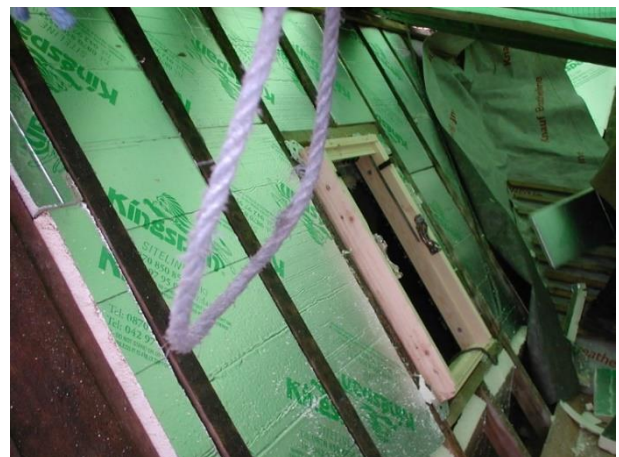
- the replacement of damaged beams with recycled ancient timbers wherever possible;
- the repointing of all the chimneys;
- the installation of Kingspan insulation boards and breathable membranes between the rafters;

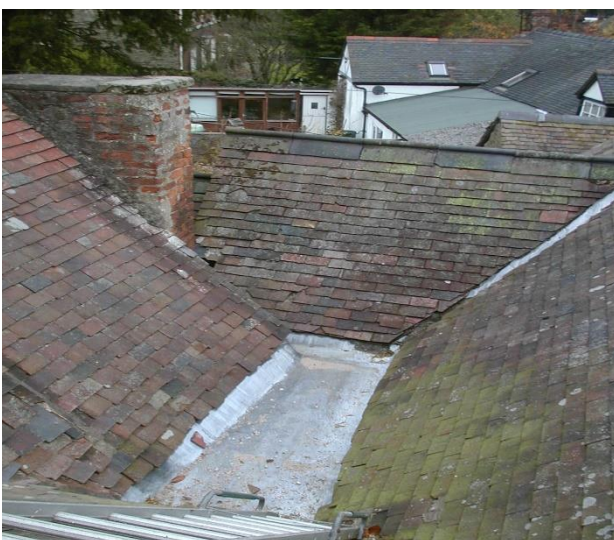
- the filling of roof spaces with Rockwool insulation;
- the complete retiling of the roof to replace the many broken tiles. As many reusable ancient tiles as possible were retained.
